# **Ensuring Sustainable Solutions for Metals and Associated Contaminants at DOD Facilities**

Robert Stanforth and Steven Schroeder

RMT, Inc

June 17, 2010

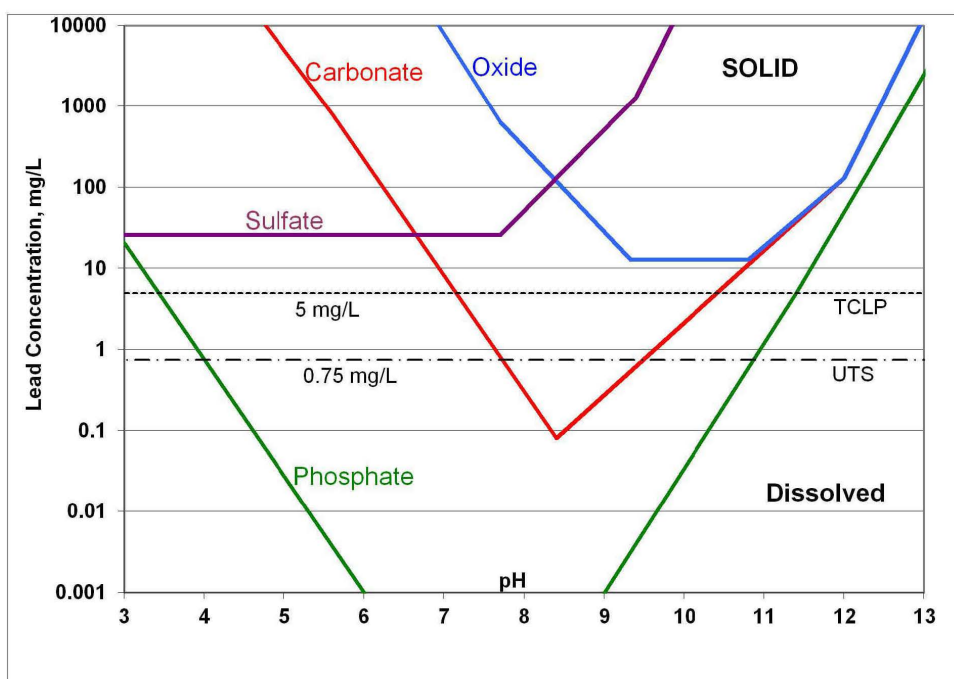
## Solubility of Lead Species as a Function of pH

**Lead forms highly insoluble phosphate compounds, can be used to stabilize lead against leaching in both regulatory leaching tests and in natural environment**

**Solubility shown in log concentration- pH plot (Next Slide)**

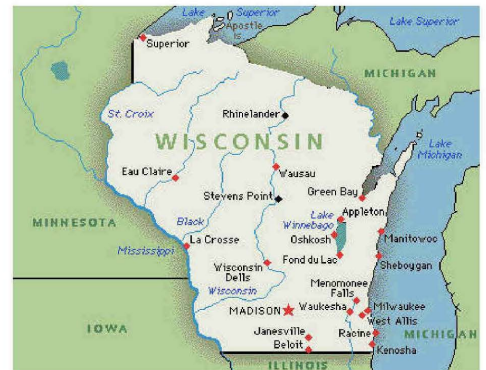
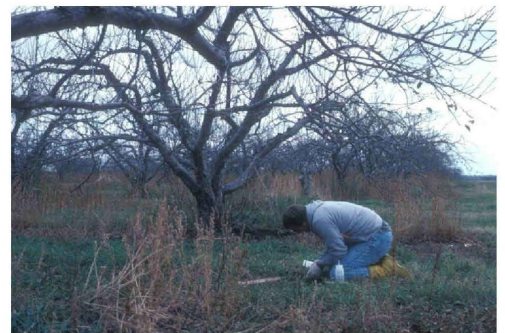
**Lead arsenate widely used as pesticide prior introduction of DDT**

**One application was on apple and cherry orchards**

**Soil in Door County, Wisconsin found to contain both lead and arsenic, groundwater had elevated lead levels.**

**Source was tracked to the use of lead arsenate in the orchards**

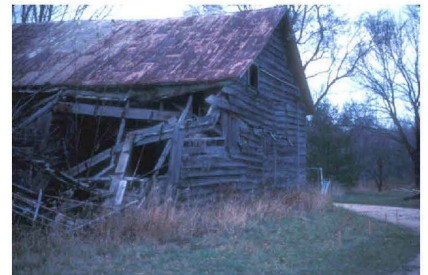
**Evaluated use of pH adjustment to control arsenic leaching (by calcium arsenate formation)**

TCLP Test Results			
	pH	As	Pb
Soil A			
Untreated	5.1	<0.2	370
+2.5% TSP	5.1	<0.2	7.5
+5.0 % TSP	5.0	<0.2	3.6
+ 10% TSP		<0.2	0.4
Soil B			
Untreated	5.1	2.2	18.6
+ 5.0 % TSP	5.1	9.3	<0.6
+ 5.0 % TSP + 5% MgO	6.6	7.3	<0.2
+ 5.0 % TSP + 10% MgO	10.0	0.098	<0.2

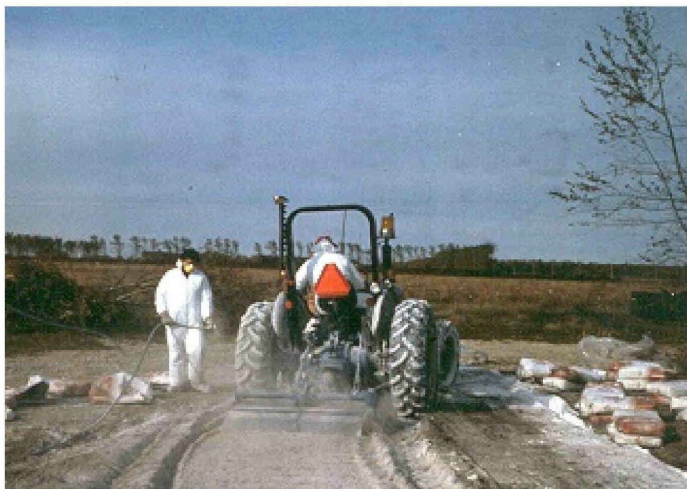
**Results: Both arsenic and lead leaching can be controlled using phosphate and pH control.**

**Chemistry successfully applied at a number of small sites**

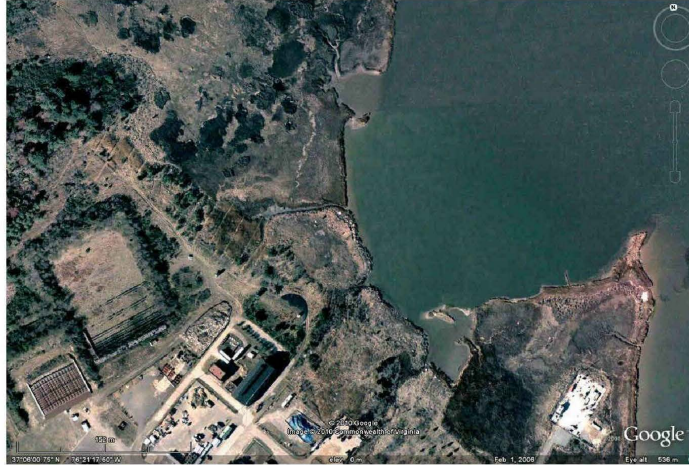
- Located between NW and SW branches of the Back River (Chesapeake Bay)
- Skeet shooting range – lead shot and target debris
- Elevated lead (~250 mg/l) in soils on range and sediments in cove (~18 mg/l)
- Chemical stabilization cannot increase levels of phosphate in Back River
